CRITICALITY ACCIDENTS

WHEN, WHERE, CONSEQUENCES
LESSONS LEARNED

Thomas P. McLaughlin, Consultant

A Review of Criticality Accidents

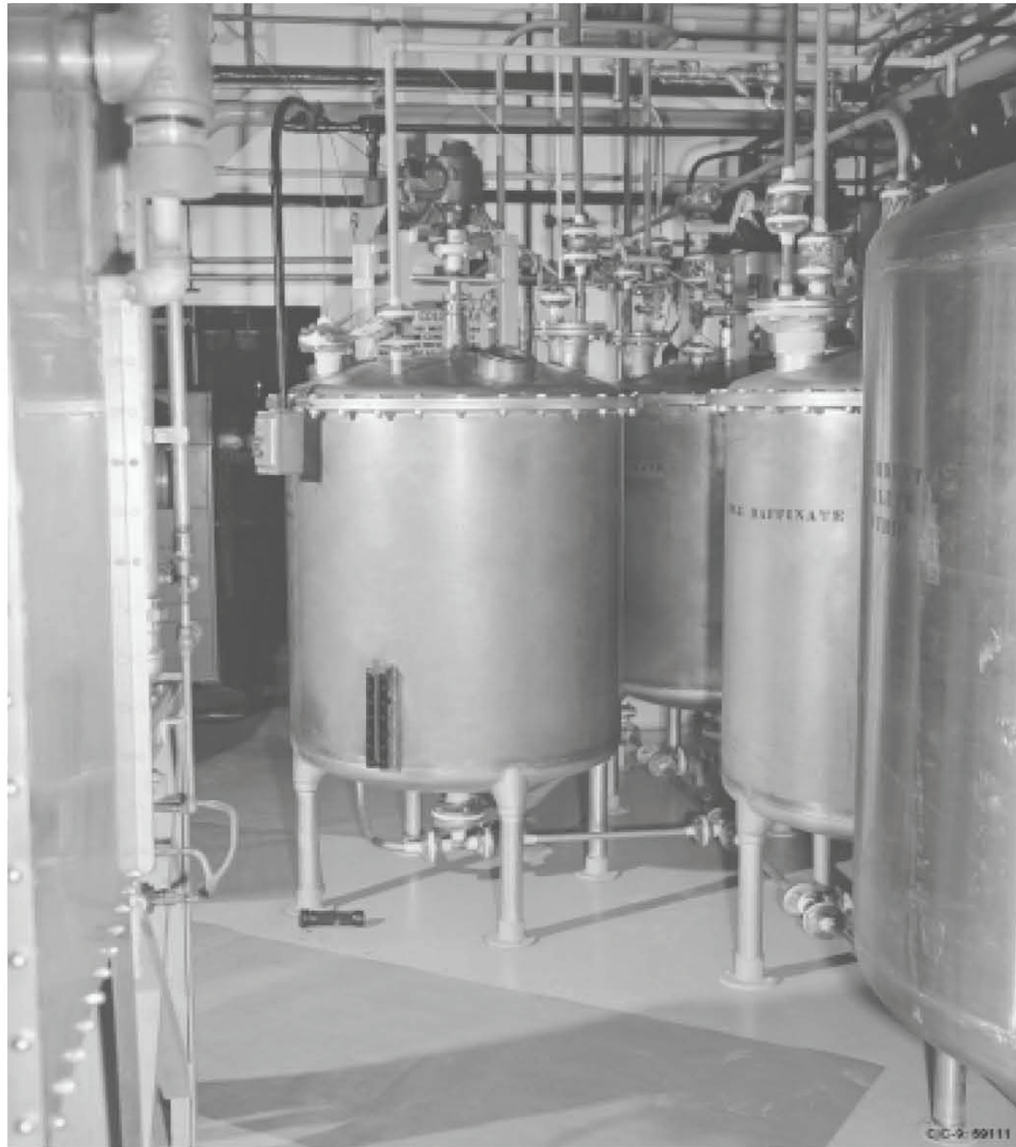
Figure 12. Vessel in which the 1958 Los Alamos process criticality accident occurred.

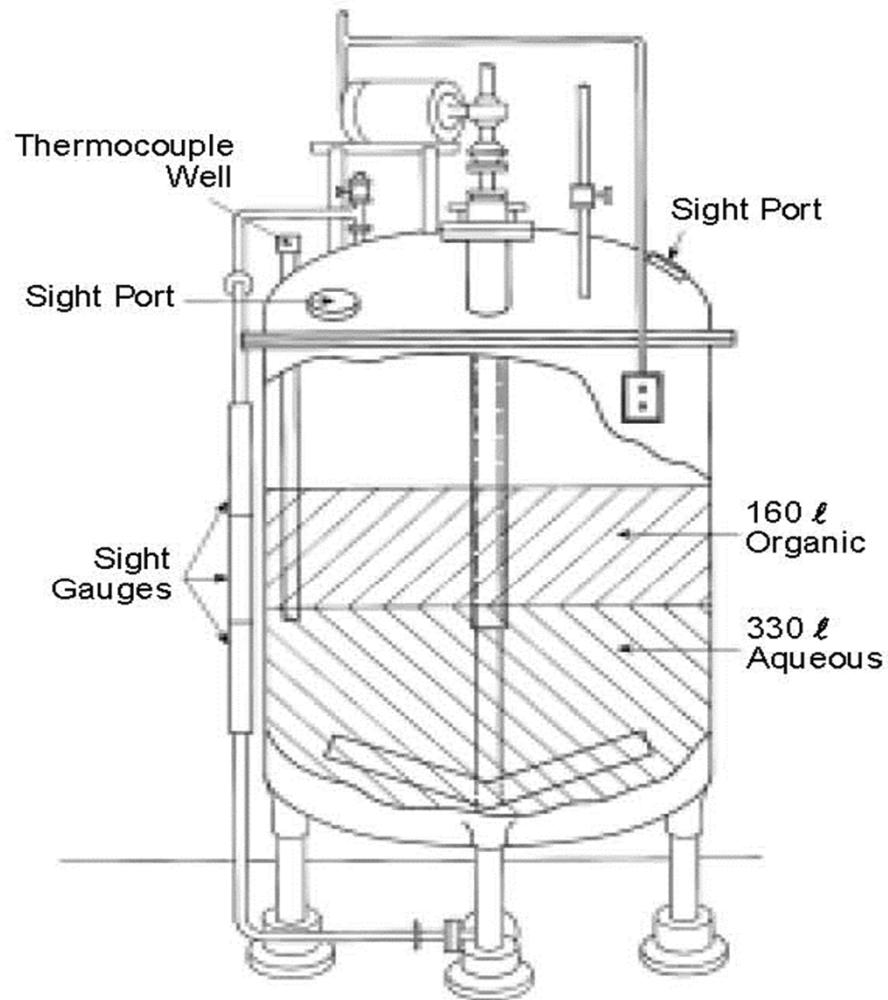
Figure 11. Configuration of solutions (aqueous and organic) in the vessel before the accident.

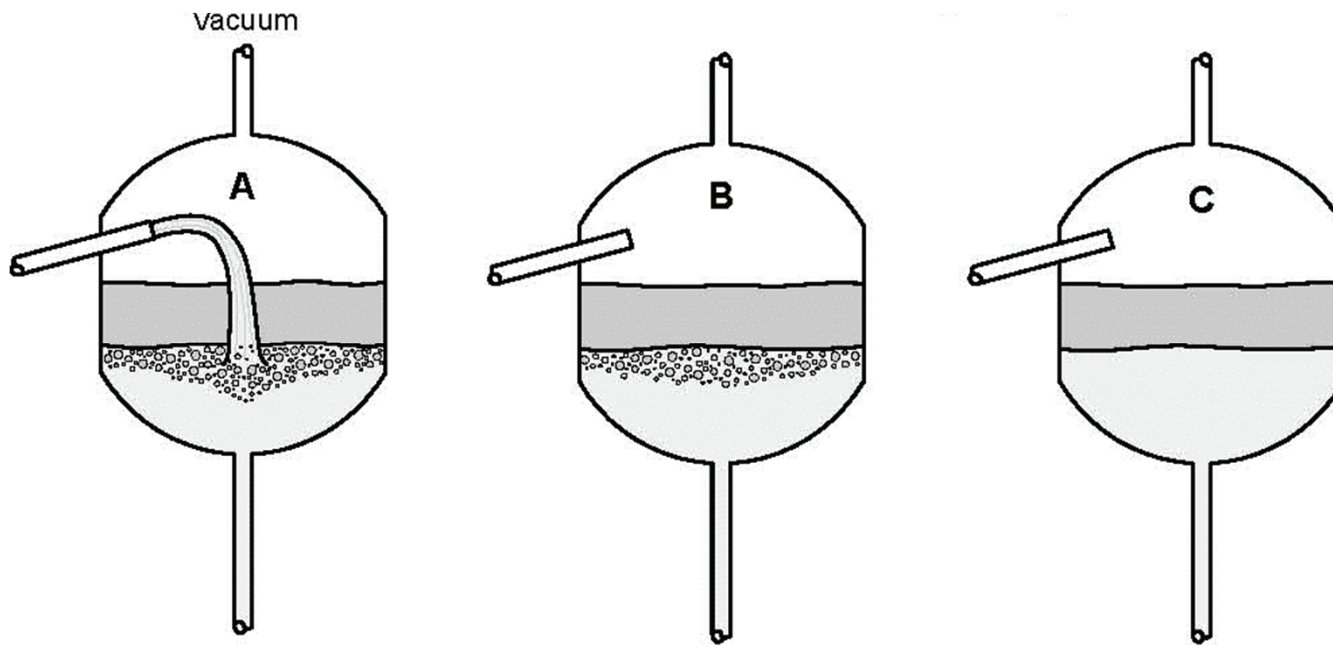
Figure 26. Solution transfer as reconstructed from the transparent plastic mockup of the transfer vessel. Configuration (B) is the postulated state at the time of the accident.

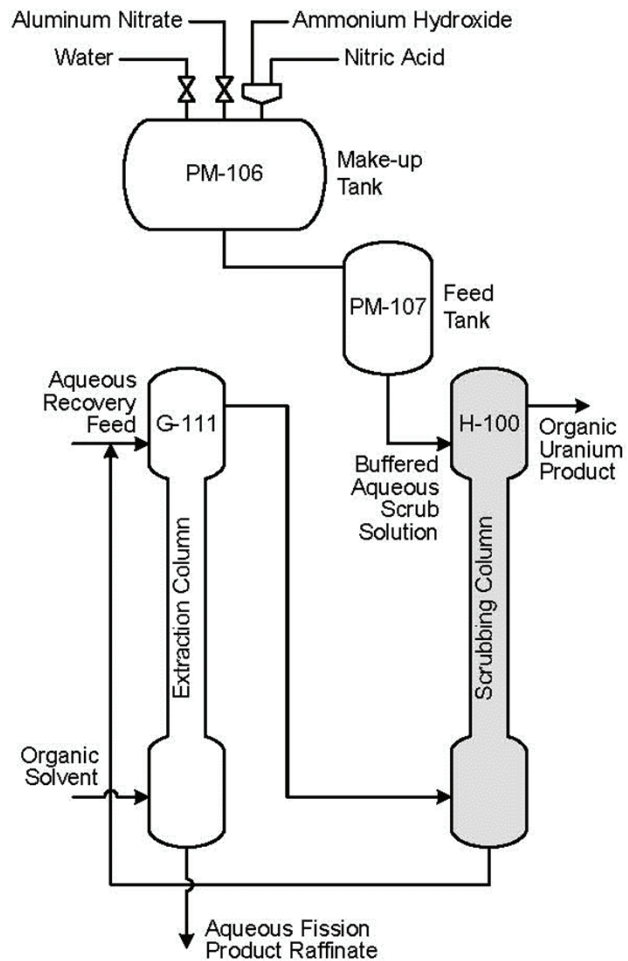
Figure 27. First cycle extraction line equipment. The accident occurred in the lower disengagement section of the H-100 column.

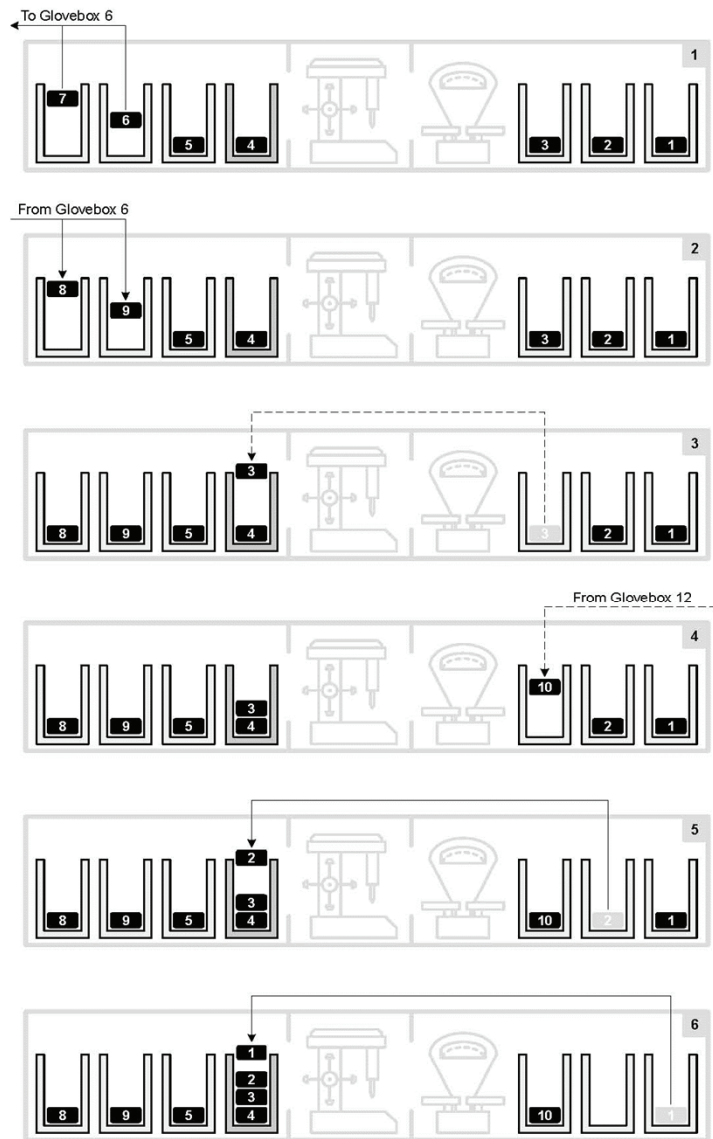
Figure 31. Actual order of ingot transfers from and to Glovebox 13. The solid lines represent the actions of operator A and the dotted lines the actions of operator B.

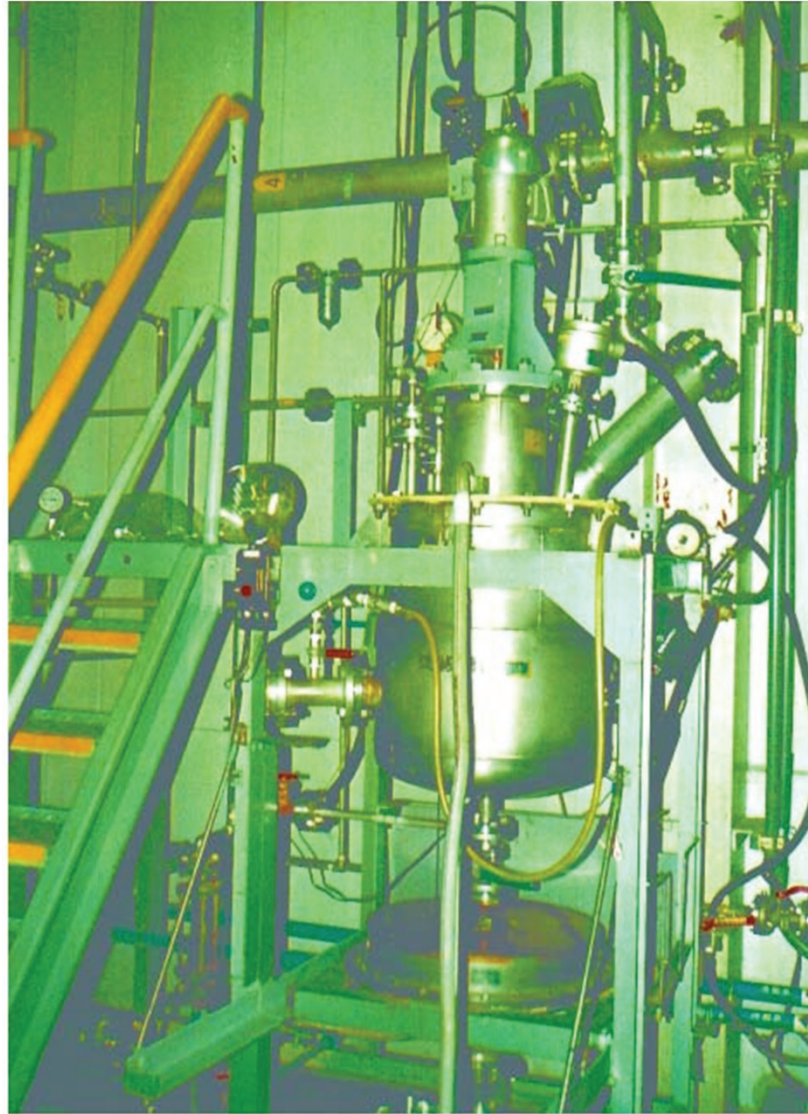
Figure 35. The precipitation vessel in which the process criticality accident occurred.

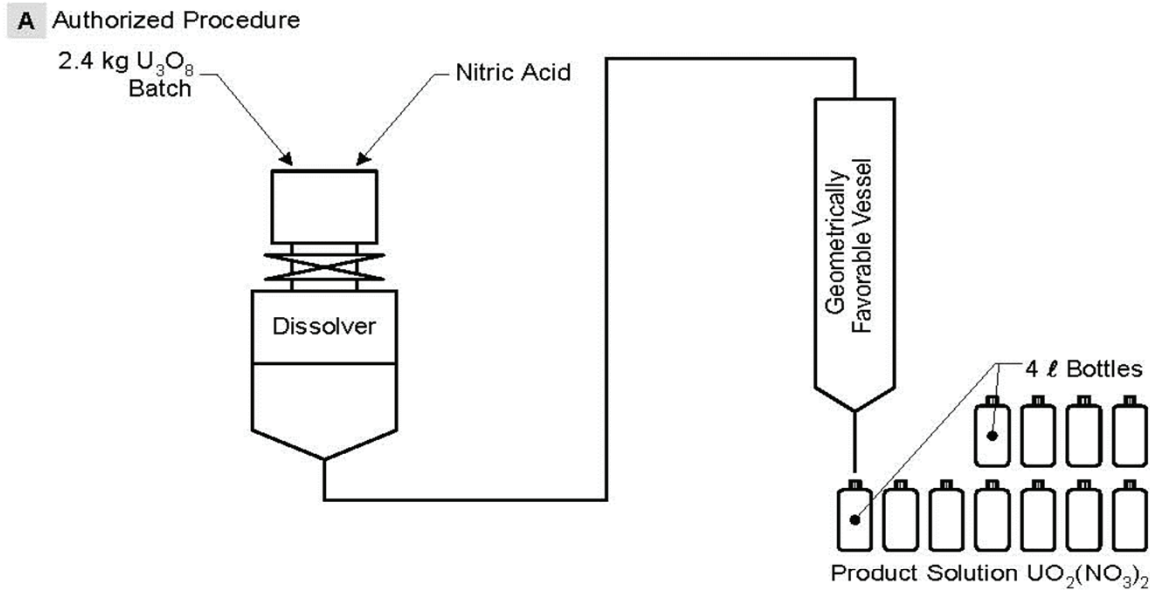
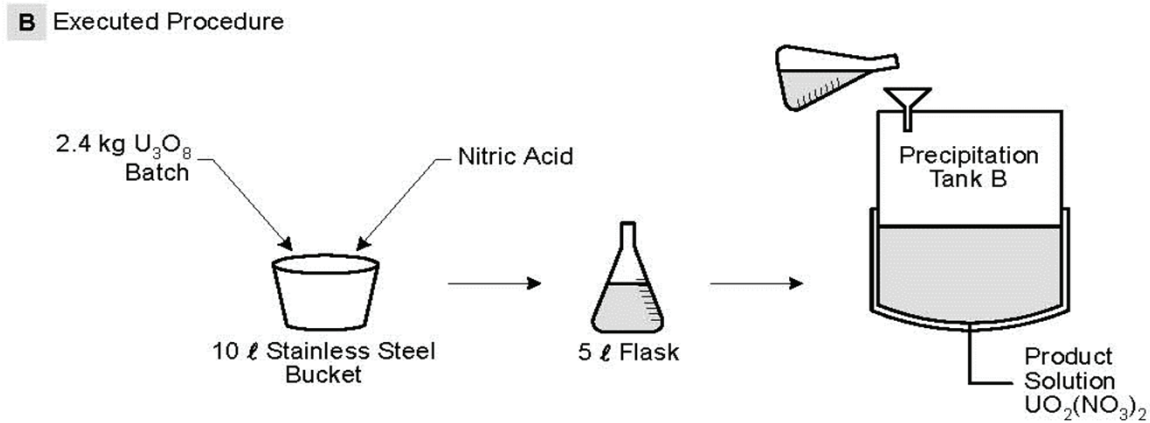
Figure 34. Authorized and executed procedures.

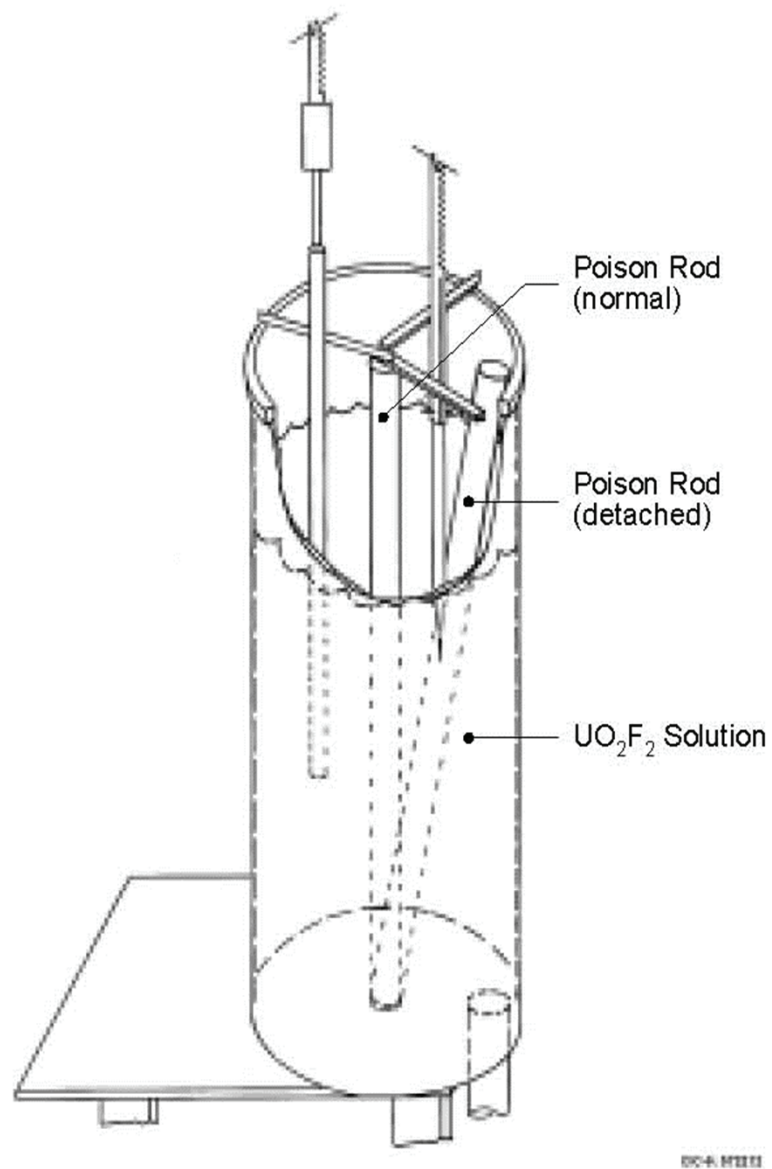
Figure 40. The Oak Ridge National Laboratory uranium solution assembly showing the normal and detached positions of the central poison rod.

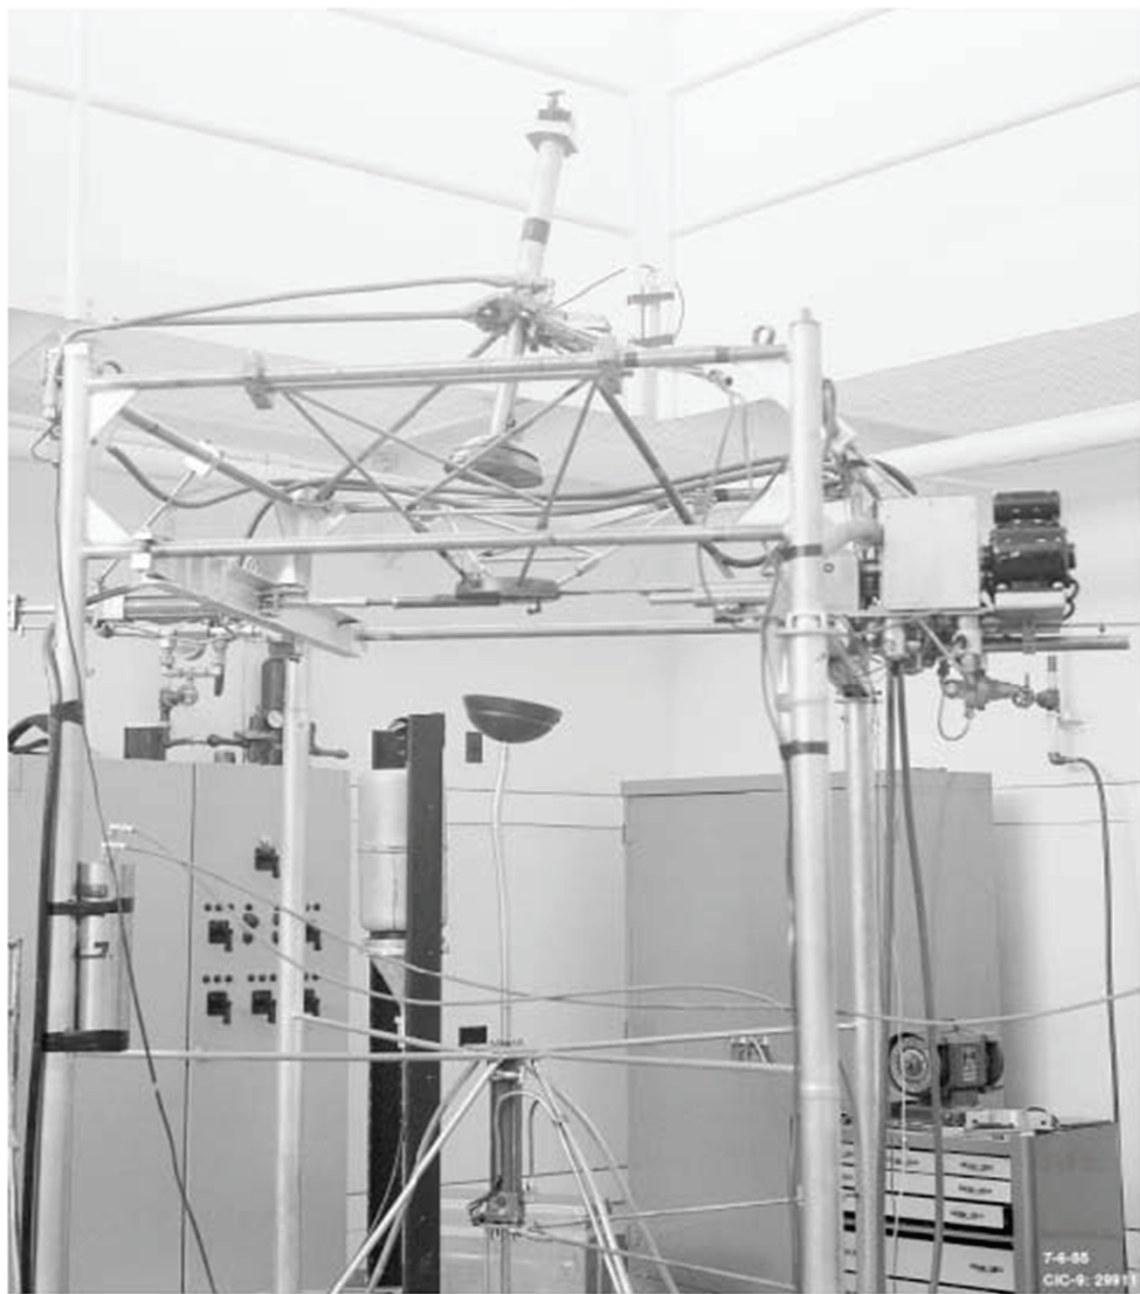
Figure 49. Lady Godiva after the excursion of 3 February 1954.

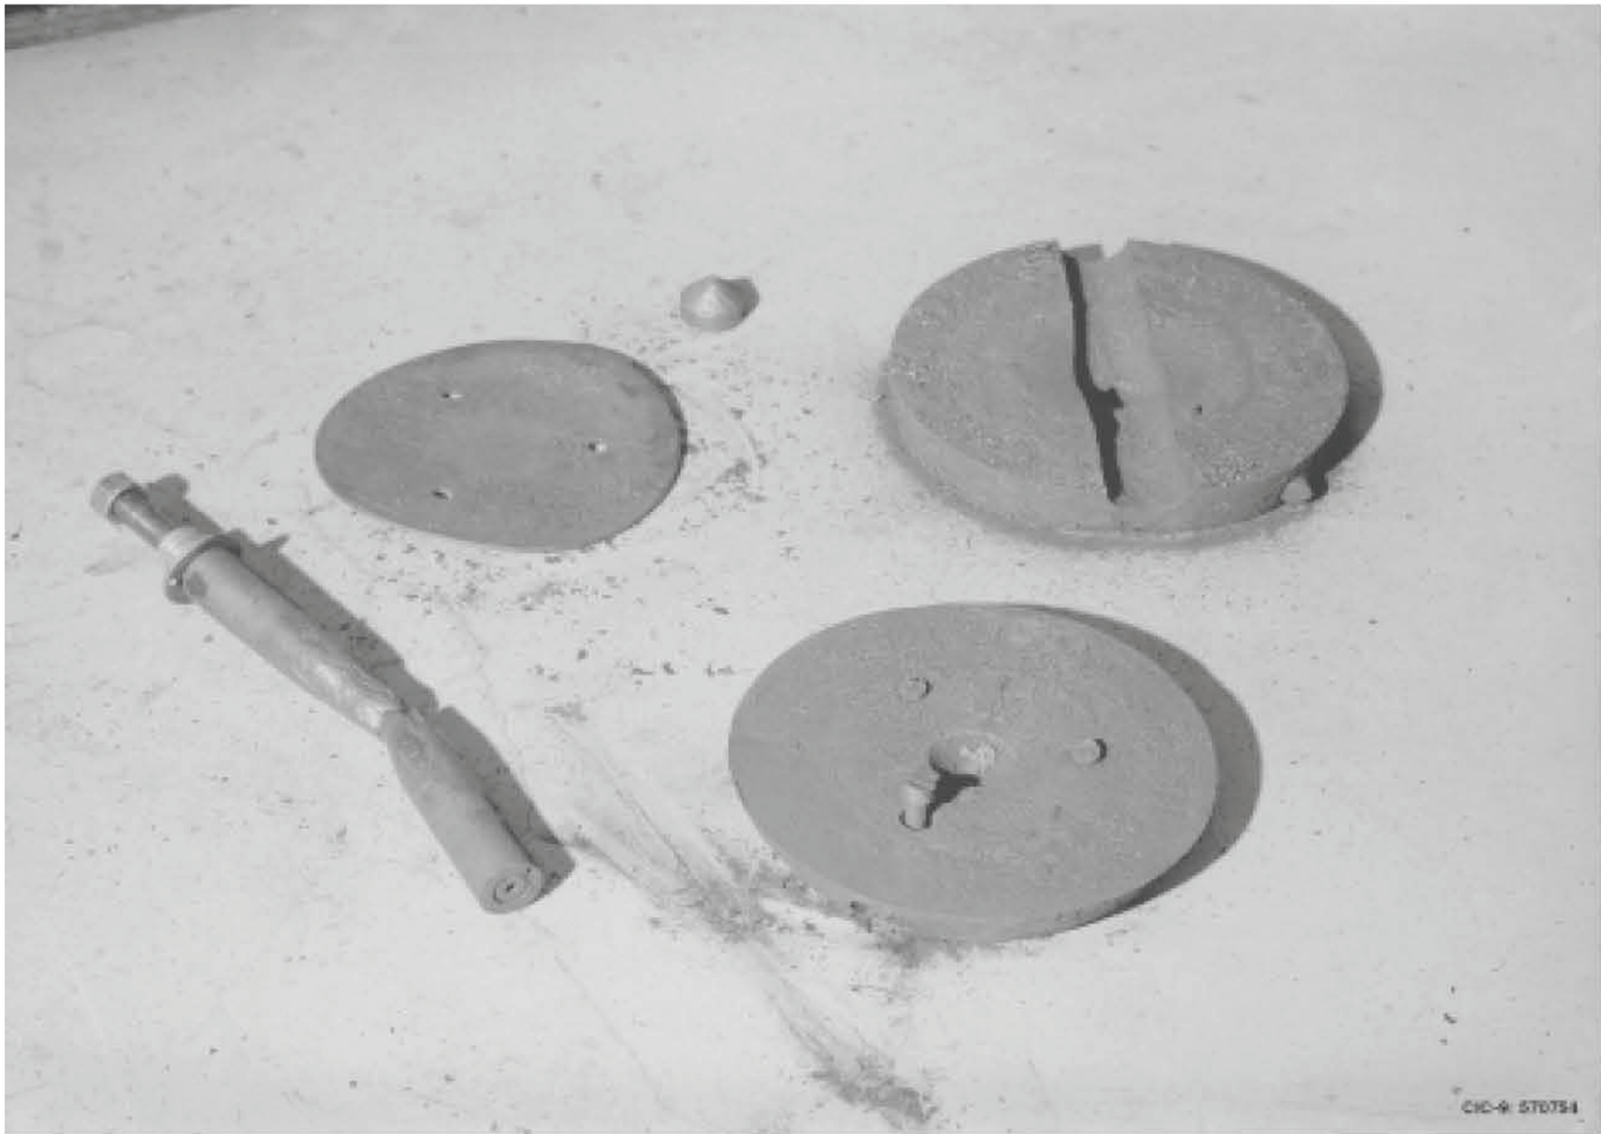
Figure 50. Burst rod and several sections of Lady Godiva showing oxidation and warpage that accompanied the second accident, 12 February 1957.

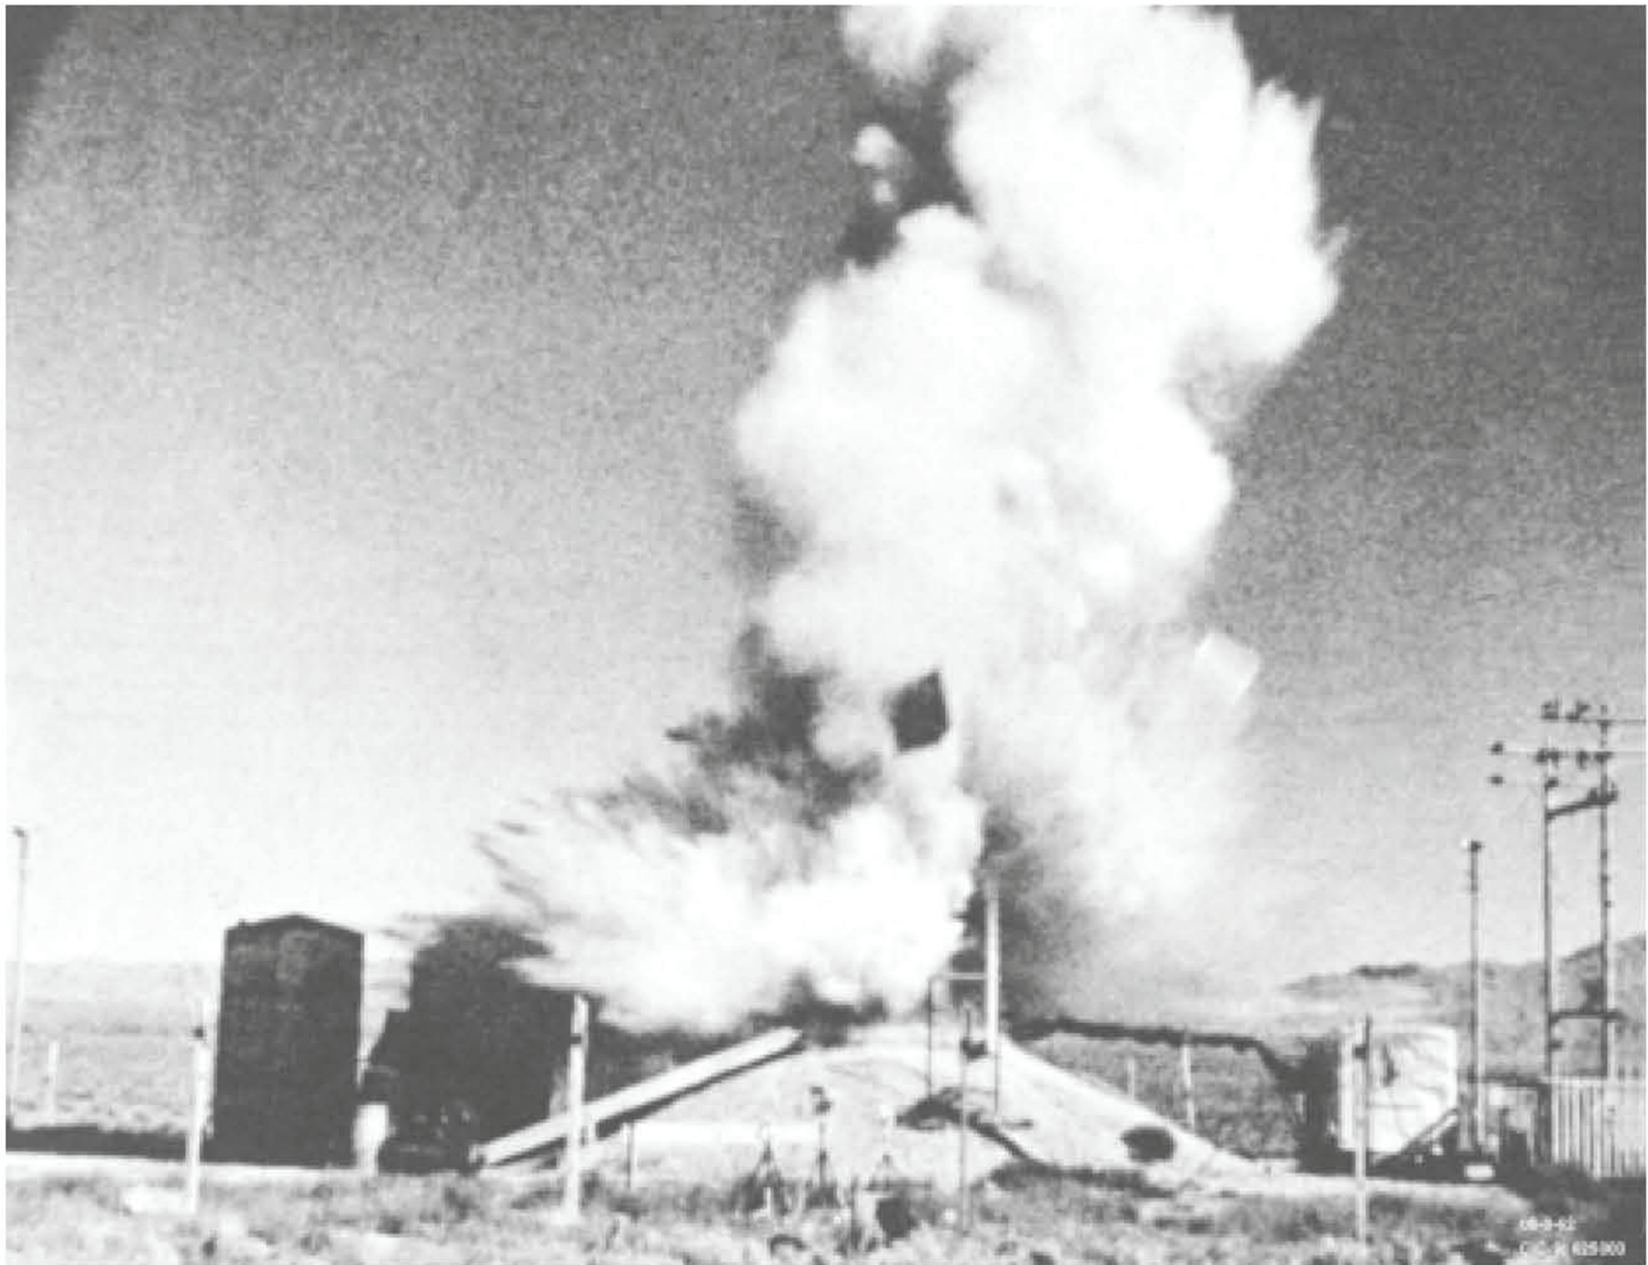
Figure 59. The destructive excursion in BORAX, 22 July 1954.
